Aviation Investigation Preliminary Report

Location:	Hebron, KY	Accident Number:	DCA26LA106
Date & Time:	January 28, 2026, 15:05 Local	Registration:	N5827K
Aircraft:	Airbus A330-343	Injuries:	2 None
Flight Conducted Under:	Part 121: Air carrier - Non-scheduled

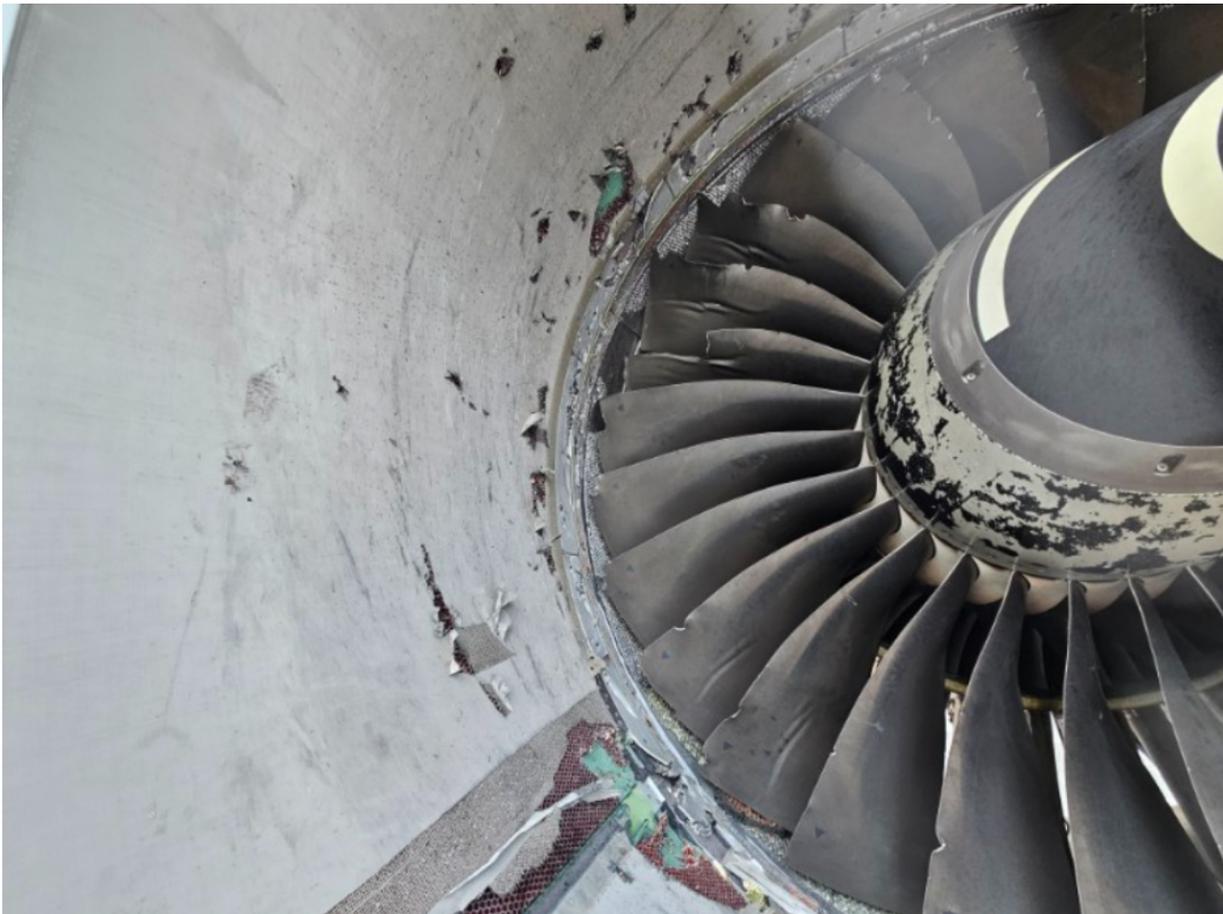
A postaccident examination of the airplane revealed bird remnants on the left main landing gear door and strut, the left-wing inboard flap, the No. 2 (right) engine pylon, the right-wing leading-edge slat and slat track. Additionally, both engines exhibited evidence of bird ingestion. Damage and bird remnants were observed on the left engine nacelle (inside and outside of the inlet) and fan blades. The left engine fan had restricted rotation and was visibly misaligned. The right engine had damage to the inlet cowl acoustic liner and bird remnants were found on the spinner and the exhaust nozzle. The right engine fan rotated freely.

Figure 1. Zoomed in picture of the left engine inlet. (Source: Alaska Airlines)

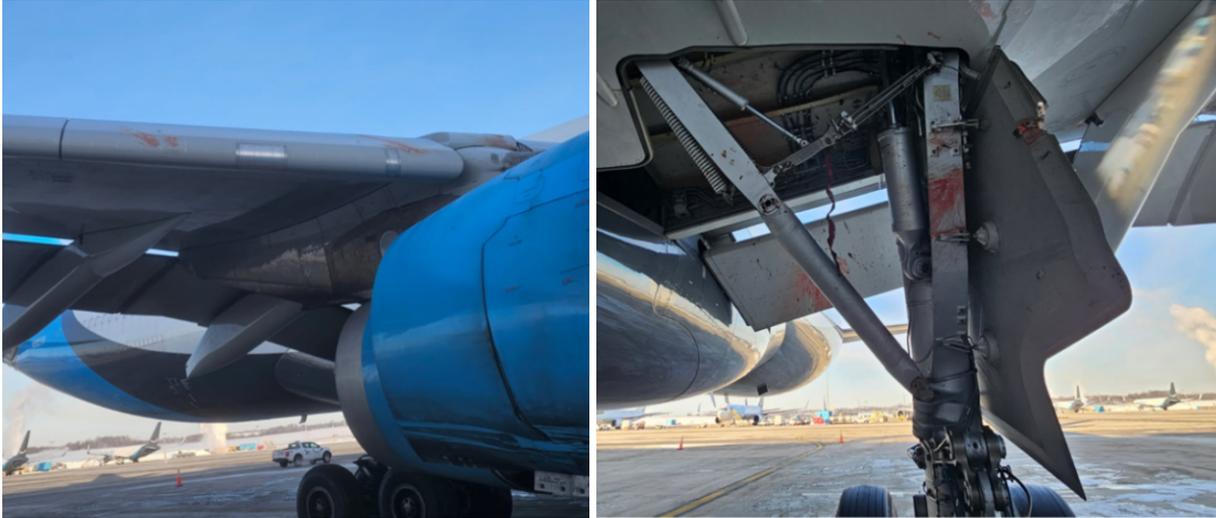
Figure 2. Right wing slat damage and left landing gear door and strut damage. (Source: Alaska Airlines)
