## **Crash: Lion B38M near Jakarta on Oct 29th 2018, aircraft lost height and crashed into Java Sea, wrong AoA data**

On Nov 28th 2018 Indonesia's KNKT (also known as NTSC) released their **preliminary report** (alternatively via AVH due to congestion at KNKT website) releasing following findings so far (editorial note: a reader made us aware that the fault code 34-21123 identified by maintenance in the tech log refers to the left hand AoA sensor, hence the left hand AoA

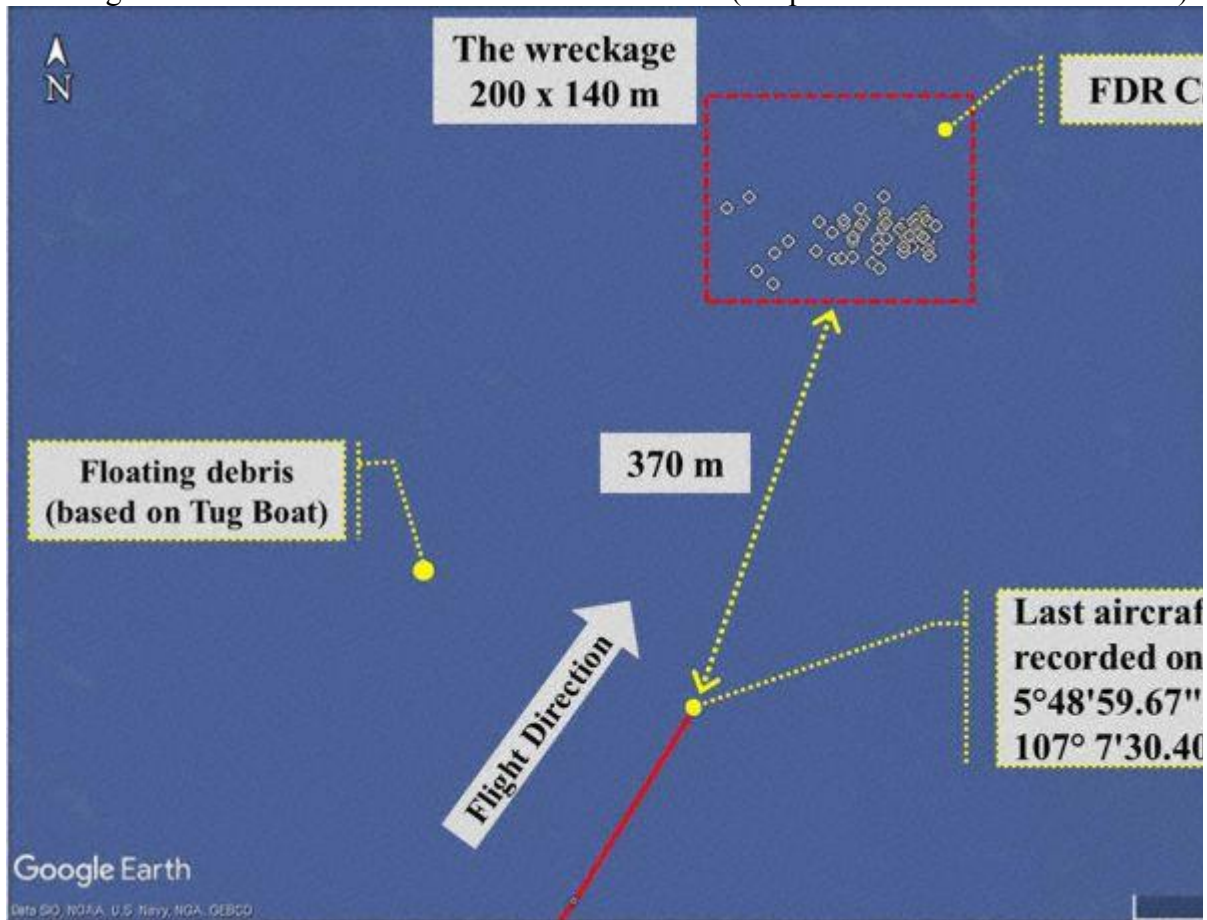
The KNKT reported that a tug boat found first floating debris at position N5.8156 E107.1231 about 35 minutes after the flight data recorder stopped recording.

Wreckage

distribution

(Graphics:

KNKT):

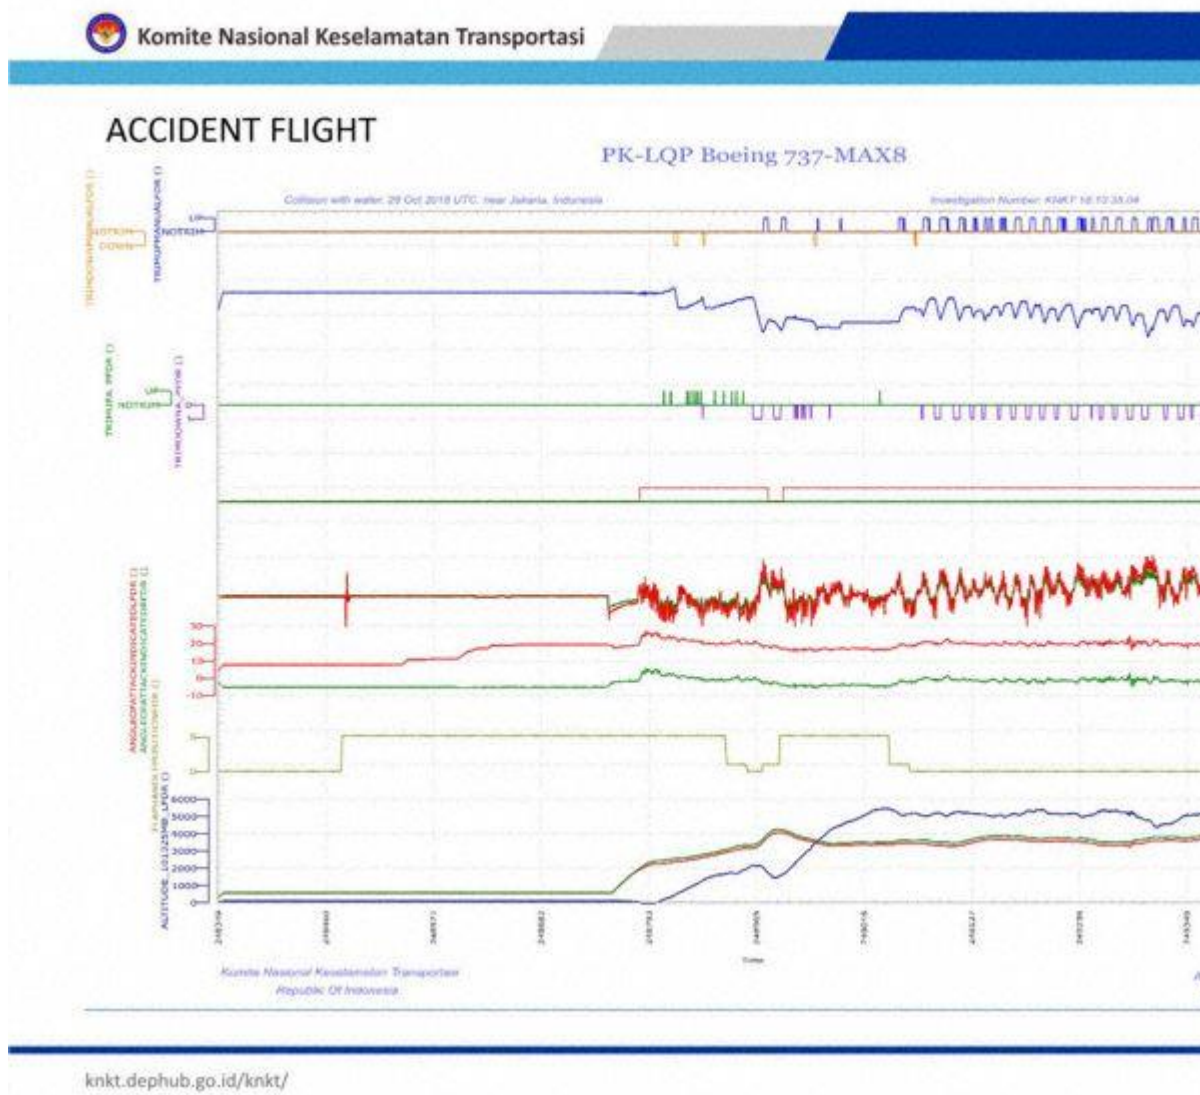
*- At 2320 UTC, (29 October 2018, 0620 LT) the aircraft departed from Jakarta using runway 25L and intended destination Pangkal Pinang. The DFDR recorded a difference between left and right Angle of Attack (AoA) of about 20° and continued until the end of recording. During rotation the left control column stick shaker activated and continued for most of the flight.*

- After the flaps retracted, the FDR recorded automatic aircraft nose down (AND) trim active for 10 seconds followed by flight crew commanded aircraft nose up (ANU) trim. The flaps extended to 5 and the automatic AND trim stopped.

- At 23:25:18 UTC, the flaps retracted to 0 and several seconds later, the automatic AND trim and flight crew commanded ANU trim recorded began again and continued for the remainder of the flight.

The FDR data released by KNKT on Nov 23rd 2018 (Graphics: KNKT):

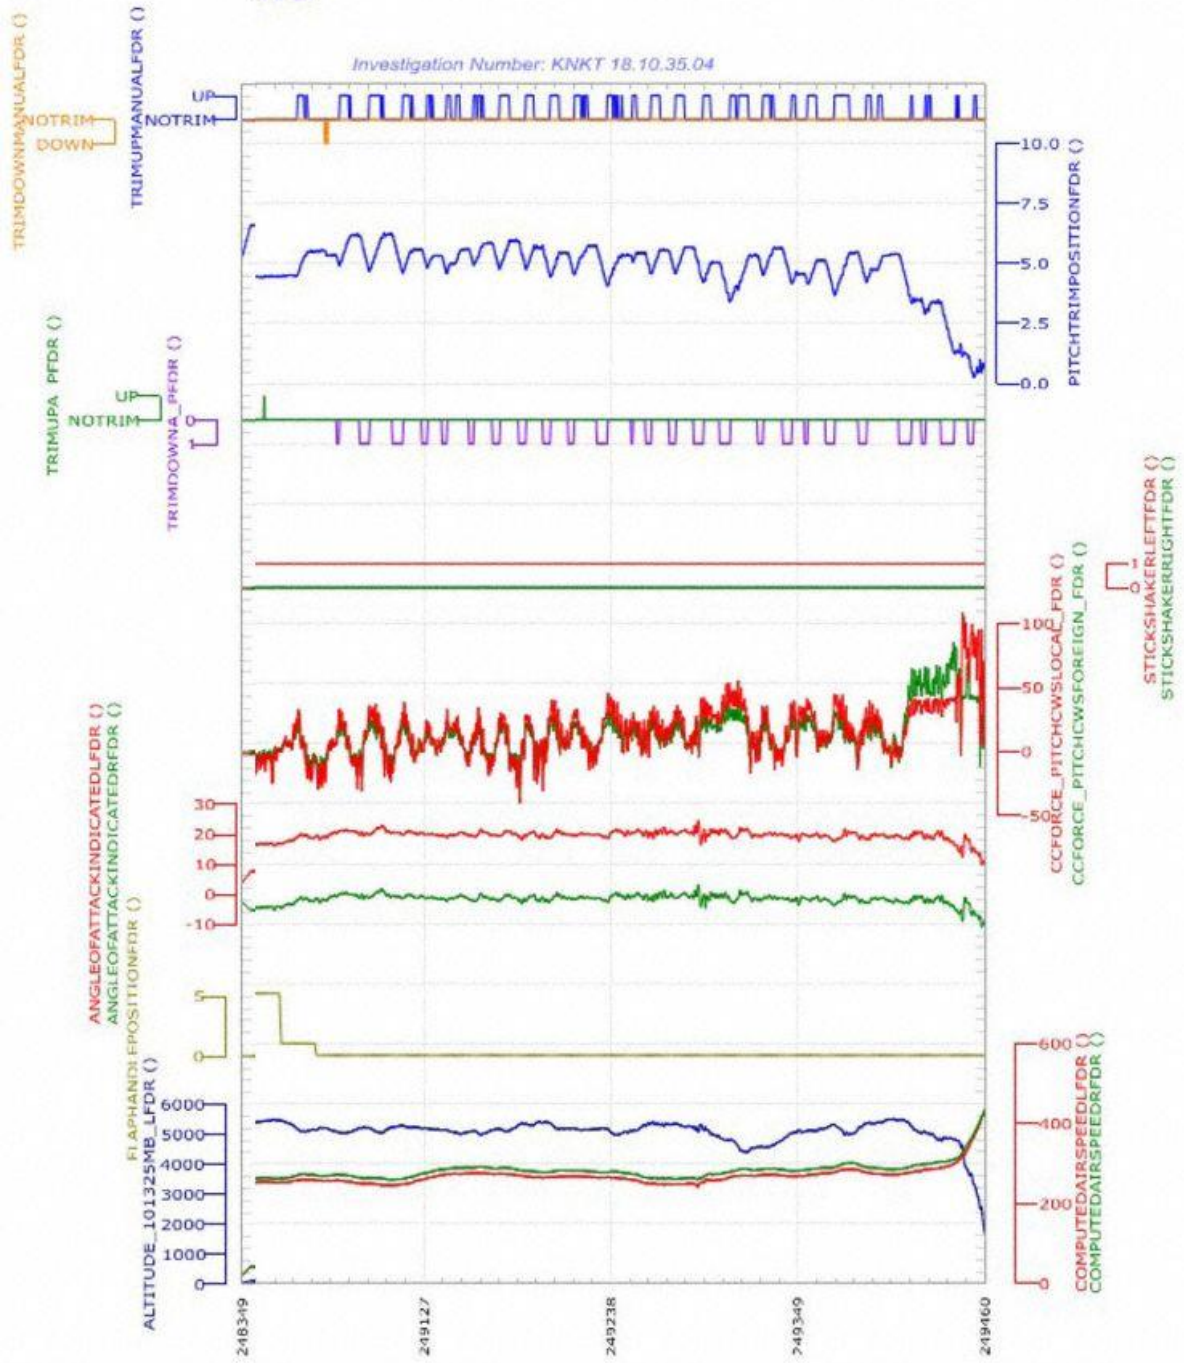
Detail of FDR data, left scale stitched to detail of crash sequence (Graphics: AVH/KNKT):

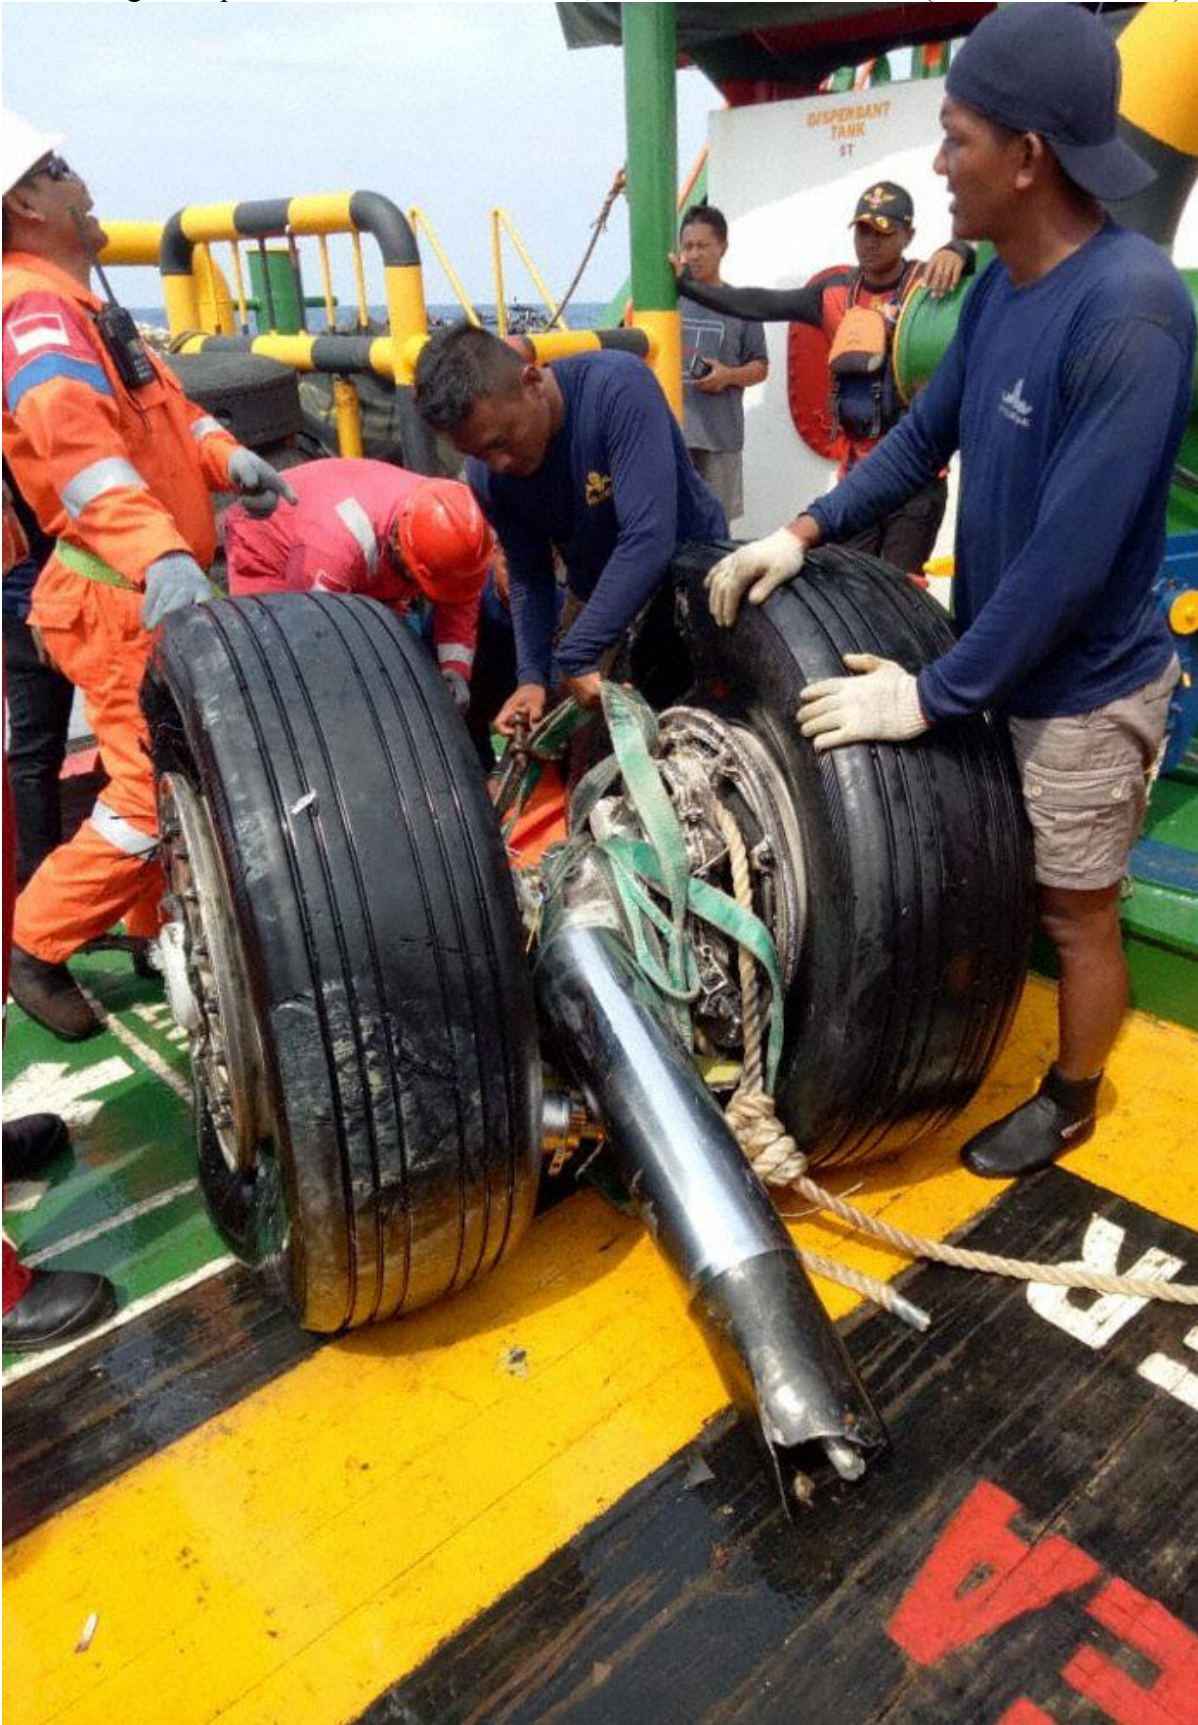
The largest part recovered so far, Nov 3rd 2018 (Photo: Basarnas):

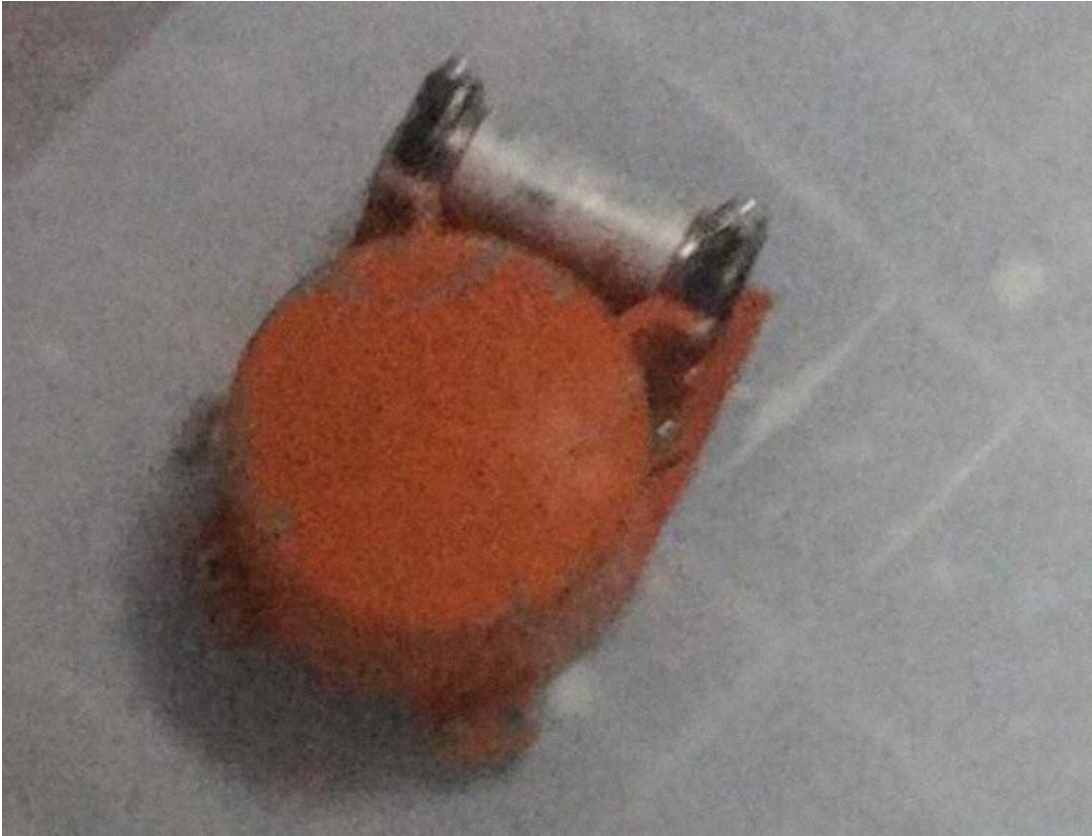
On Nov 1st 2018 Basarnas reported one of the black boxes was recovered. The black box has been handed over to KNKT for further processing and read out. The box was located at position S5.8128 E107.1269, 400 meters northeast of the last known radar position of the aircraft. A second pinger signal was located from about position S5.8133 E107.1271.

The black box found on Nov 1st 2018 (Photo: Basarnas):

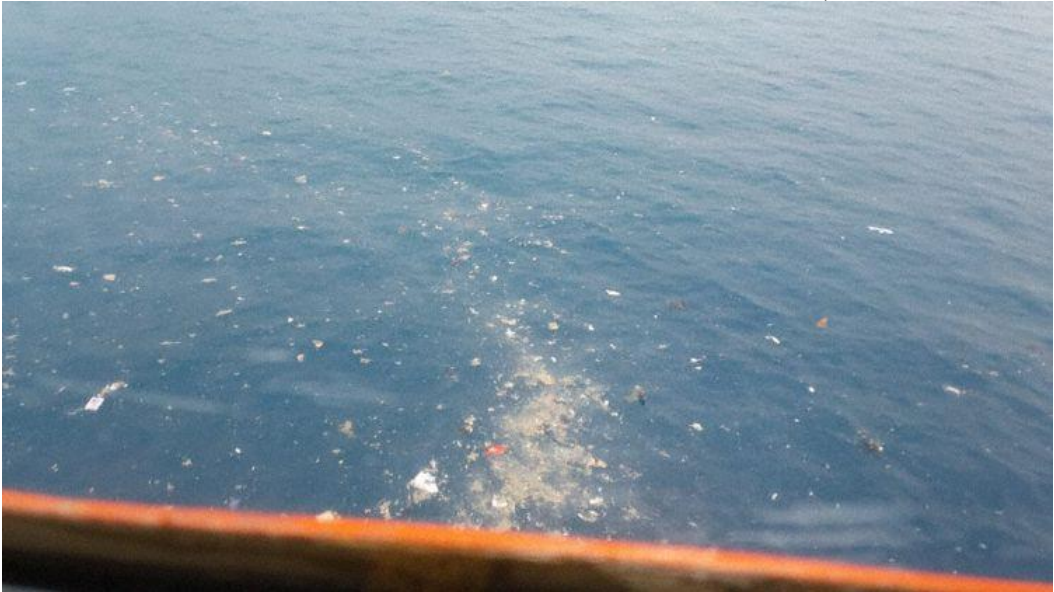
Debris in the water (Photo: Basarnas):

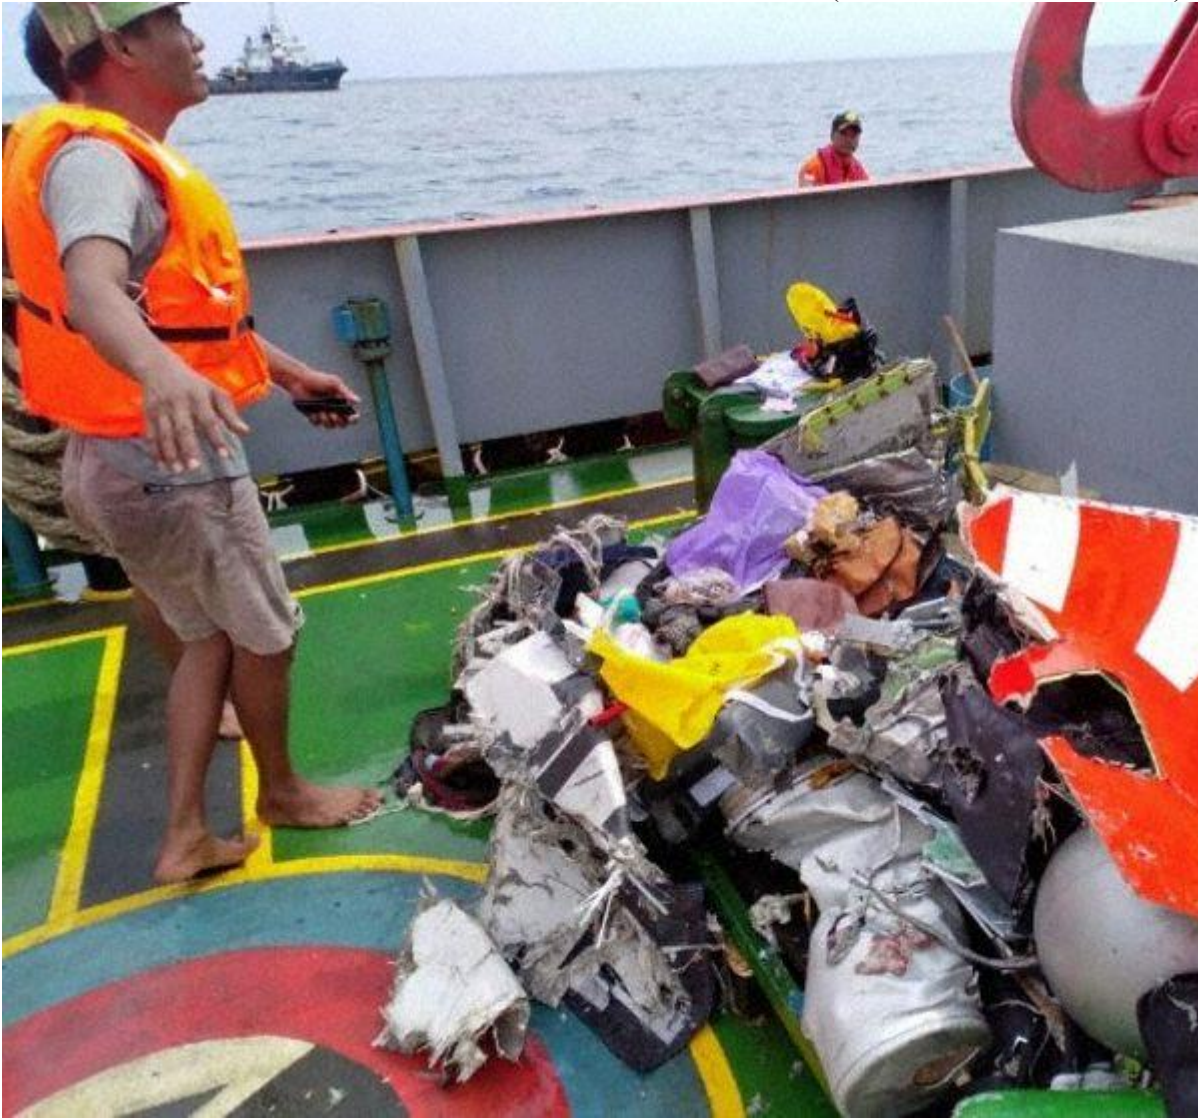
Part of recovered debris (Photo: Basarnas):
