# Air Accident Investigation Sector

### - Summary Report -

AAIS Case N° AIFN/0004/2023

## Communication Failure

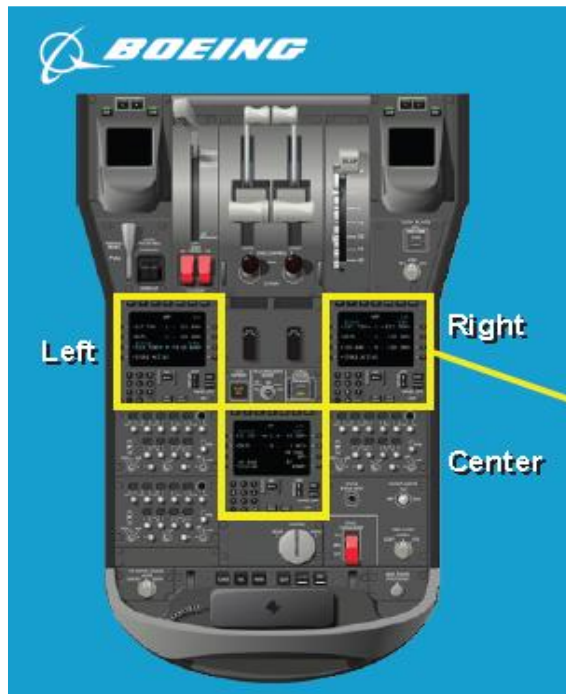
Figure 1. TCP

The TCPs are used to tune and control the very high frequency (VHF) communication system, the high frequency (HF) communication system, the satellite communication (SATCOM) system, the selective calling (SELCAL) system, and other systems. The TCPs are designated left, center, and right (figure 1), and are normally associated with the respective VHF and HF radios.

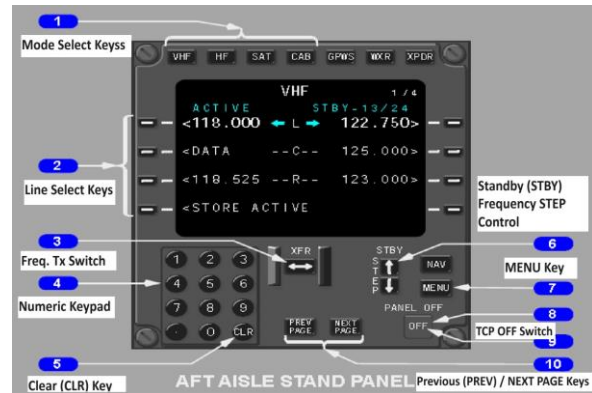
Figure 2. TCP functions

The functions of the TCP are as follows (figure 2):

Enables the pilot to choose the operating mode of the radio system, such as COM (communication), NAV (navigation), or ADF (automatic direction finder).

Adjusts the audio volume level of the selected radio system. Provides a way for the pilot to control the loudness of the audio output.
